JOB SITE REPORT

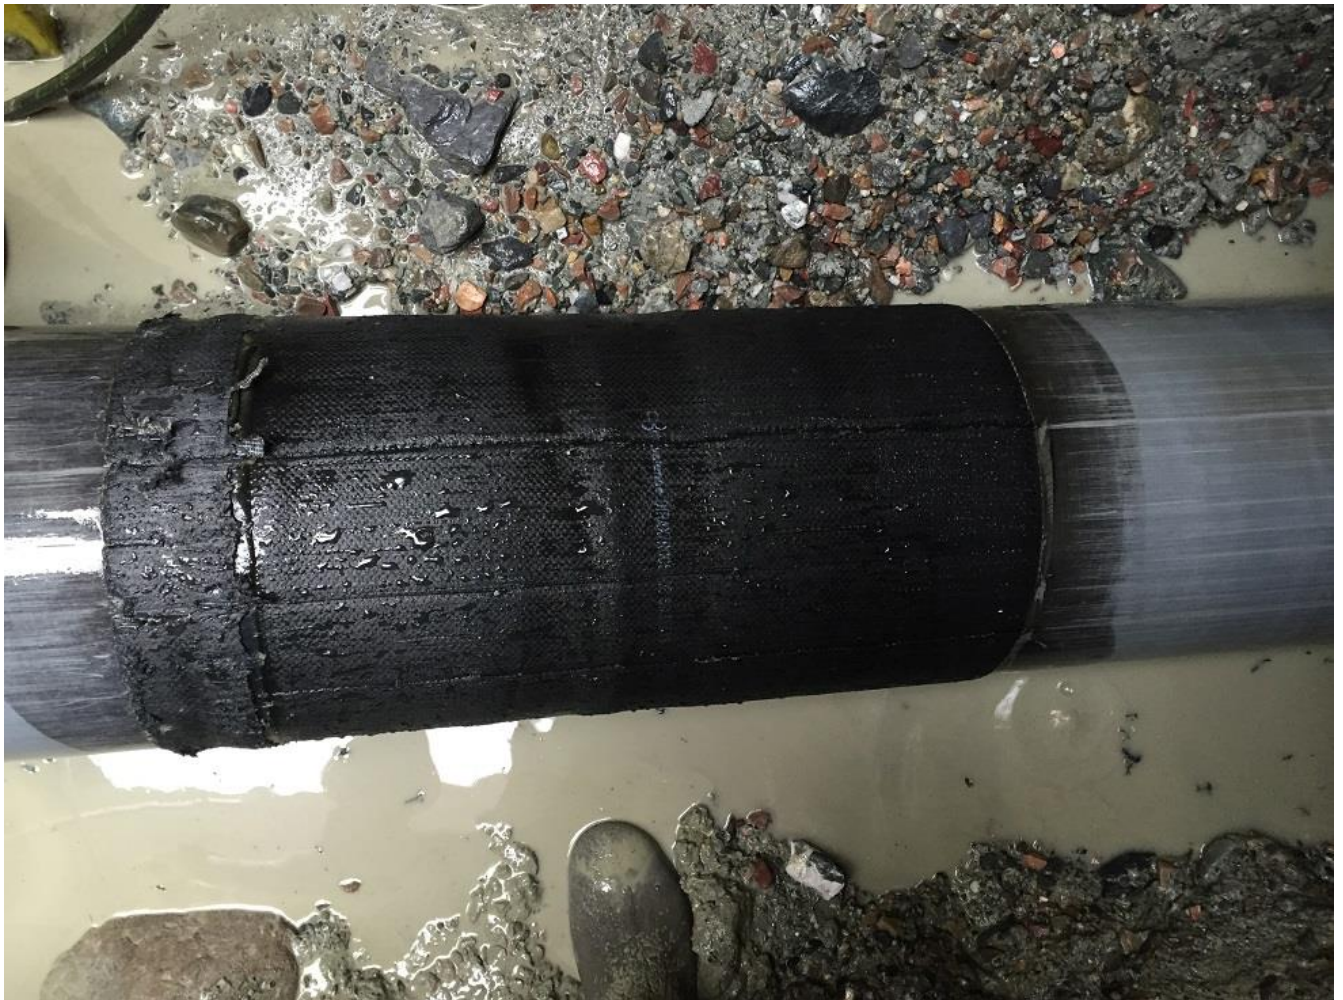
DIRAX succeeds on the third attempt where two other joint coating systems failed. The 12" Directional Bore was going through one of the toughest environments in northern Vermont of cobble and glacier till. The major concern encountered was that the joint coatings were being extremely abraded to the point where the girth weld bead was exposed to the bare metal. The Covalence Dirax Heat Shrink Sleeve was able to take the abuse and successfully complete the directional drill. The picture below depicts the forces that the directional drill was faced with. The pull is going from right to left and the picture clearly demonstrates how the leading edge or wear cone took all the abuse, as designed, to allow the Dirax Sleeve to stay in tact with minimal scuffing. Another impossible directional drill completed successfully.
