Job Site Report

16" Directional Bore

Nor'Easter no match for Dirax

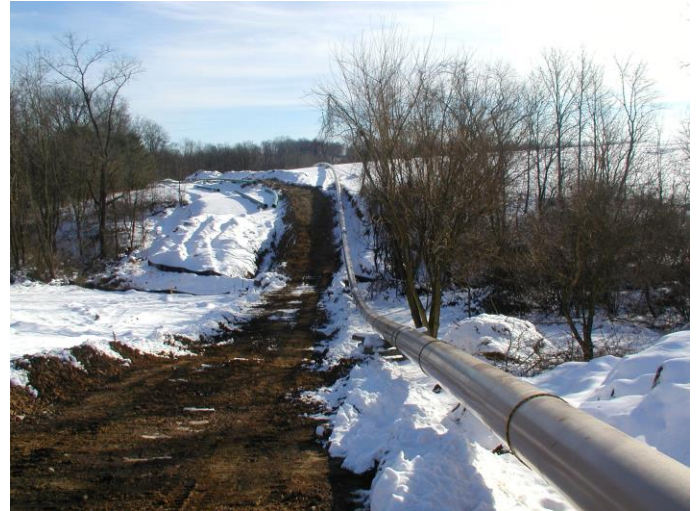
Job Site Overview

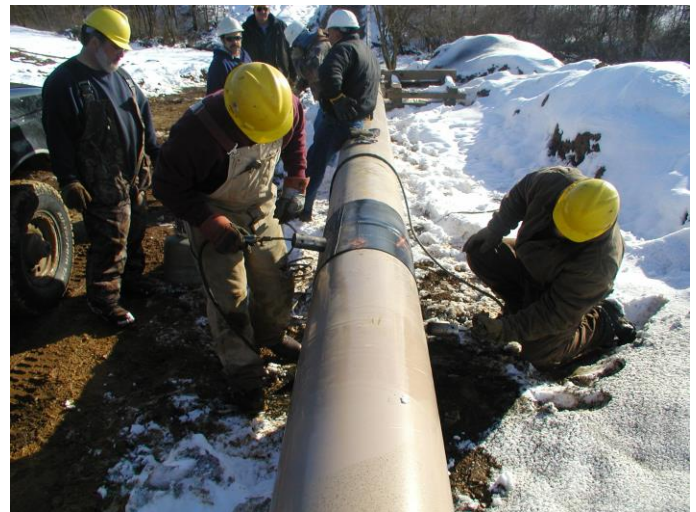
Application of Dirax Sleeve

The Gas Utility made the decision to utilize Covalence's Dirax sleeves in order to meet the construction dead line. The Dirax Sleeves were provided and field assistance within two days of notification. The liquid epoxy system was easily stripped with torches and putty knives. Once the surface preparation was completed, the Dirax was applied in less than twenty minutes and thirty minutes later the Dirax was ready for the directional bore. Construction is now back-on schedule. During this process ambient temperatures did not get above freezing.

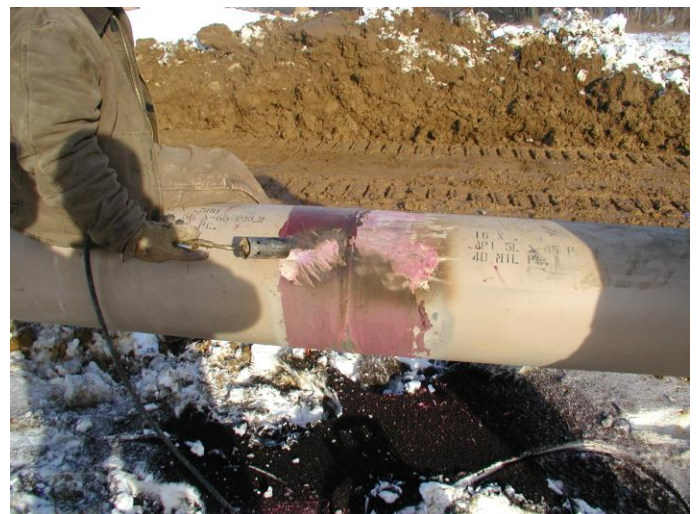
Additionally, final holiday testing showed pinhole holidays and the second layer of epoxy delaminated from the initial layer creating concern whether or not they could get all the joints coated and ready to go in 6 days.

Removal of Liquid Epoxy System
